Exhibit 4

Digital photographs taken by Jay Kalan, City of Murrieta on January 28, 2003 at the Ryland Homes of California, Inc., Serenada site.

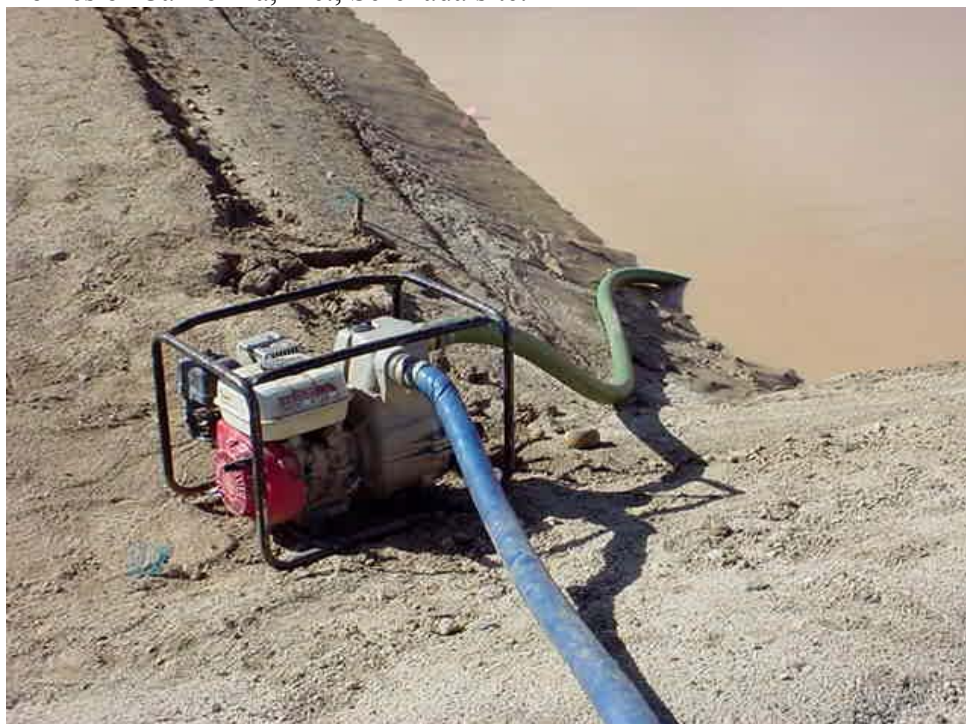
Photograph MVC-016S.JPG depicts the pumping of sediment laden water from sedimentation basin.

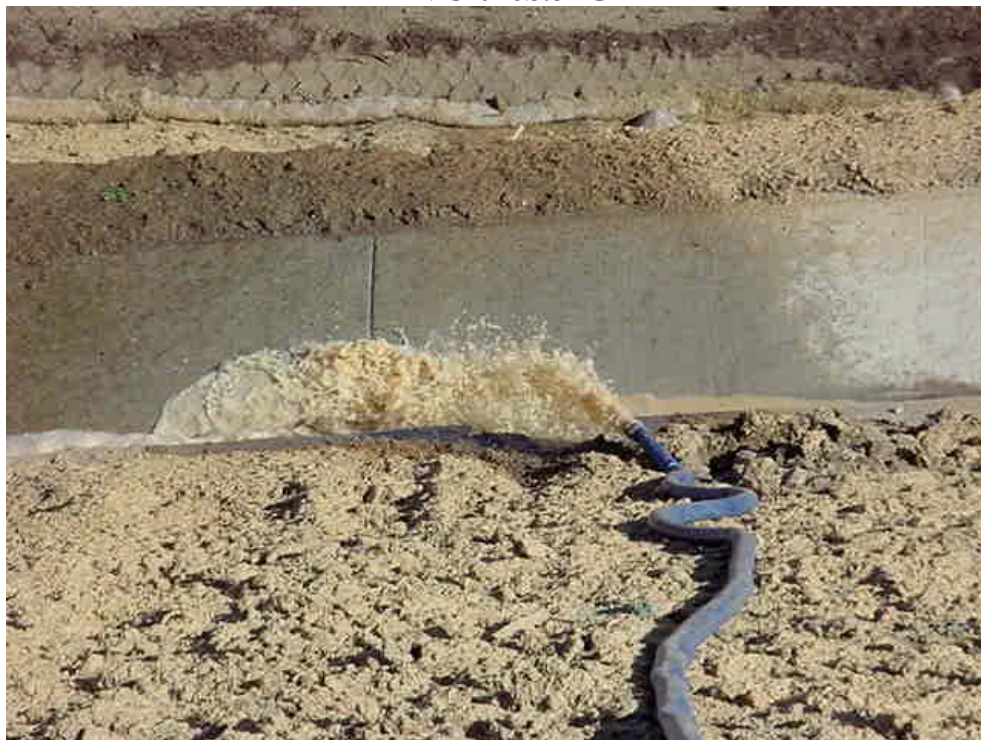
Photograph MVC-017S.JPG depicts the discharge of the sediment laden water to concrete v-ditch connected to the City of Murrieta's storm water conveyance system.
